## City of Fort Myers Uses RCP to Fix Decade-Old Storm Sewer Problem October 6, 2011

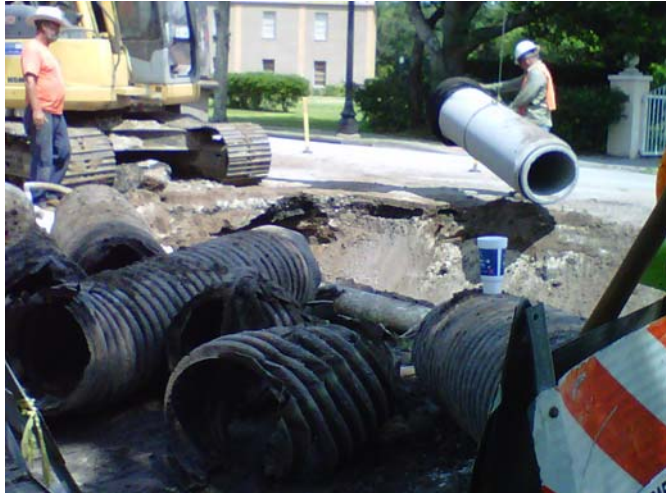
Figure 1. 18-inch ASTM C76 Class III RCP replaces less-than 15-year old corrugated HDPE pipe.

The replacement pipe was 18-inch diameter ASTM C76 Class III RCP, which has a minimum design load supporting strength of 1,350 pounds per foot diameter per foot length (lbs/ft/ft) and minimum ultimate load strength of 2,000 lbs/ft/ft. Based on American Concrete Pipe Association (ACPA) Fill Height Tables, RCP in similar conditions should be specified based on a design service load of approximately 600 lbs/ft/ft.<sup>2</sup> Clearly, RCP has a significant structural safety factor. For installations such as required by FDOT specifications, the ACPA Fill Height Table indicates that 18-inch Class III RCP may be specified to an installation depth of 22 feet. Unlike flexible pipes, rigid RCP supports the entire overburden. Therefore RCP is in-plant strength tested to certify that the product was manufactured to support the design and yield loads required of the installed service conditions.

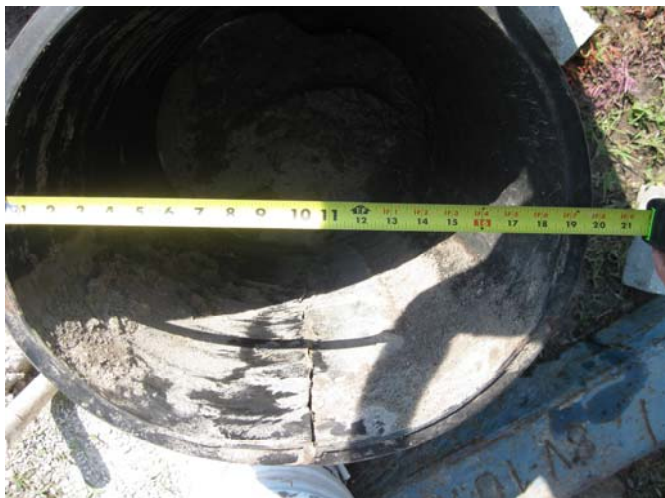
The McGregor Blvd. pavement had depressed in this section, and video inspections verified deformation of the HDPE pipe.<sup>1</sup> Upon excavation, it was discovered that the HDPE pipe had developed longitudinal cracking completely through the walls of the inner liner and outer corrugations along the invert and obvert. Longitudinal cracks traversed the springline of the outer corrugations, and circumferential cracks were observed in the inner liner at the junction with the outer corrugation. Corrugation growth had developed in various sections along the longitudinal axis and circumference of liner sections.

Figure 2. Upon excavation, some of the 18-inch HDPE pipe remained deformed, with horizontal dimensions of 19 to 20 inches and cracks along the invert.

According to the city, one of the longitudinally cracked invert sections had hinged upward at the haunches resulting in an inverted heart shape in the pipe. In-situ conditions along McGregor generally appear typical for Florida storm sewer installations. According to the City of Fort Myers, the natural groundwater elevation fluctuates and is generally two to three feet above the pipe crown. Pipe cover height was approximately six feet from the pipe crown to roadway surface. When using flexible pipe, contractors should verify that engineering indicates the pipe will structurally perform and not deform 5% or more, as required by the FDOT.

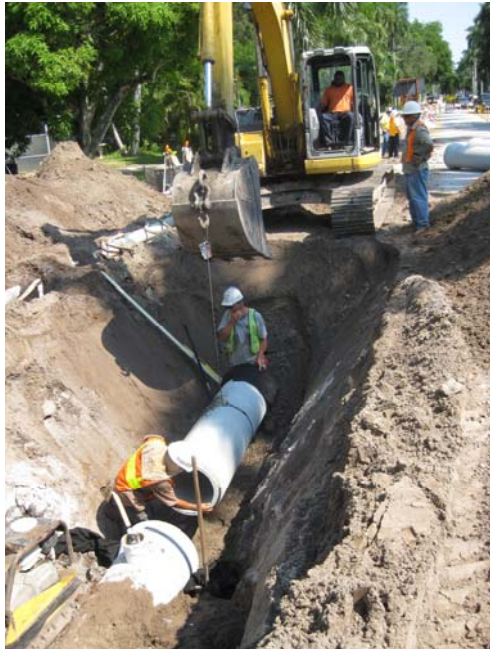
Figure 3. RCP joints were efficiently installed and tightly homed.

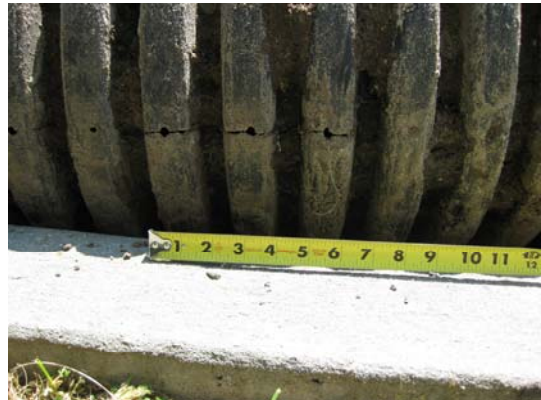
Figure 4. Longitudinal cracks developed through HDPE corrugation pierce punch holes.
