## 63x98 HERCP Replaces Corrugated Metal Culverts in Osceola County, Florida

June 15, 2011 – Osceola County is investing in the efficiency and safety of travelers along Canoe Creek Road. Four separate culvert crossings along Canoe Creek Road in Osceola County, just west of Kenansville, will be upgraded. Deteriorating corrugated metal culverts are being replaced with 63-inch x 98-inch horizontal elliptical reinforced concrete pipe (RCP) and 48-inch round RCP. Some of the corrugated metal pipe appears to have been originally produced with bituminous coating, but it is now deteriorating from the surface. The HERCP was produced by Rinker Materials Concrete Pipe Division.

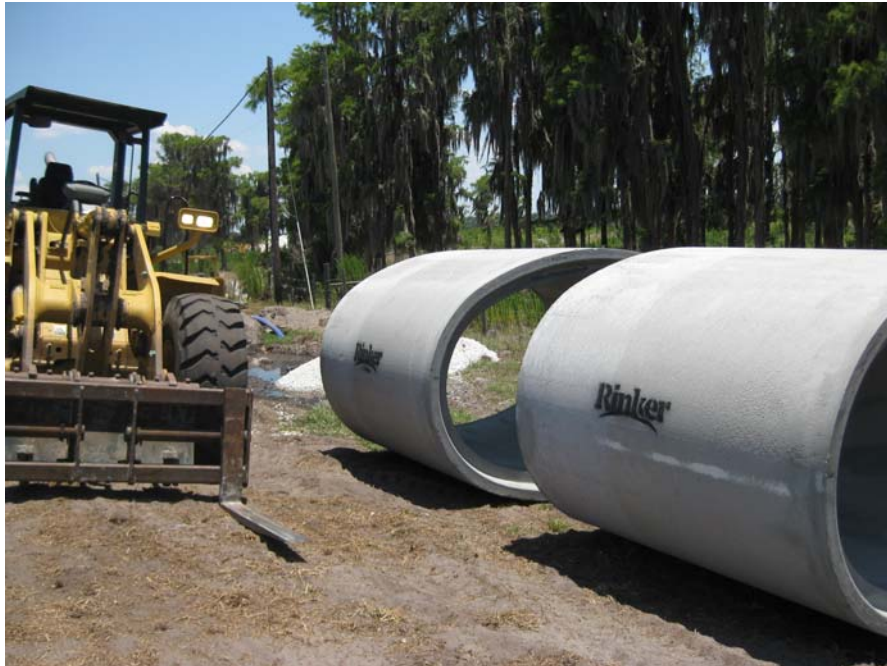
Figure 1.63x98 Horizontal Elliptical Reinforced Concrete Pipe (HERCP) Supplied by Rinker Materials Concrete Pipe Division.

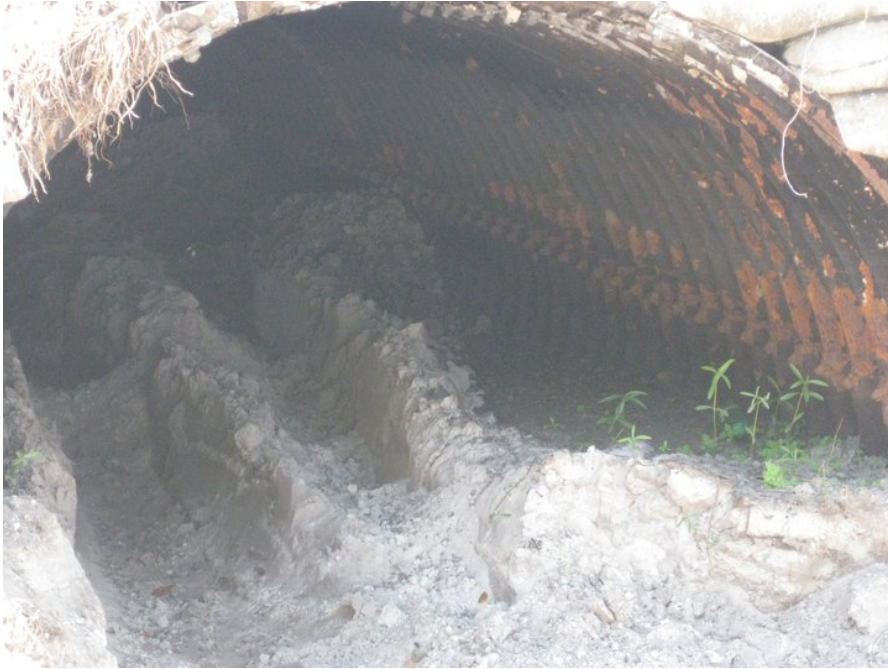
Figure 2. Corrugated metal pipe deteriorating along Canoe Creek Road in Osceola County, Florida. This CMP appears to have been originally bituminous coated.

Two dual -pipe runs of failing corrugated metal pipe (CMP) and one triple-pipe run of CMP will be replaced with the 63x98 HERCP. One single run of failing CMP will be replaced with 48-inch RCP.

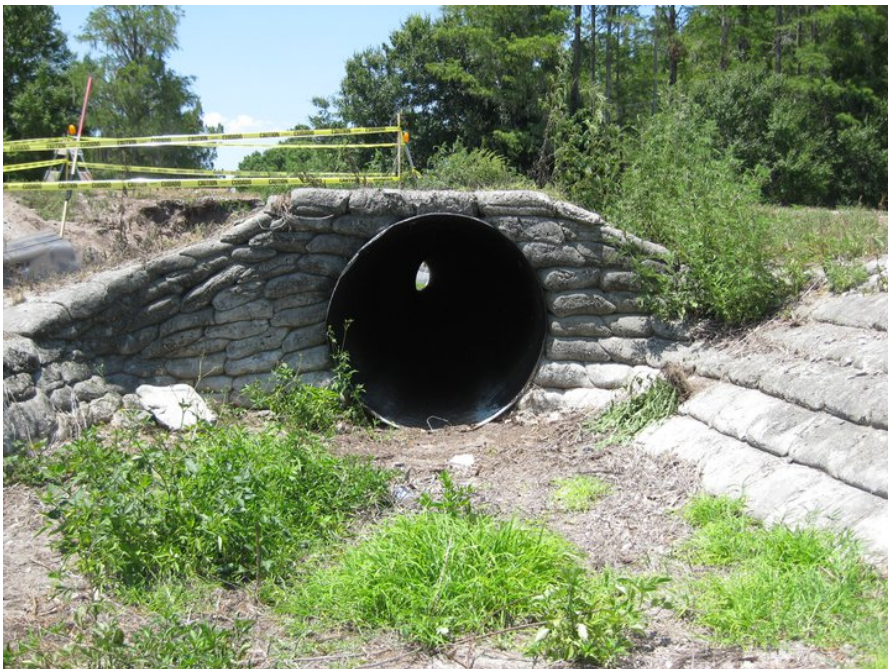
Figure 3. Corrugated metal pipe to be replaced. The pipe has become egg-shaped.

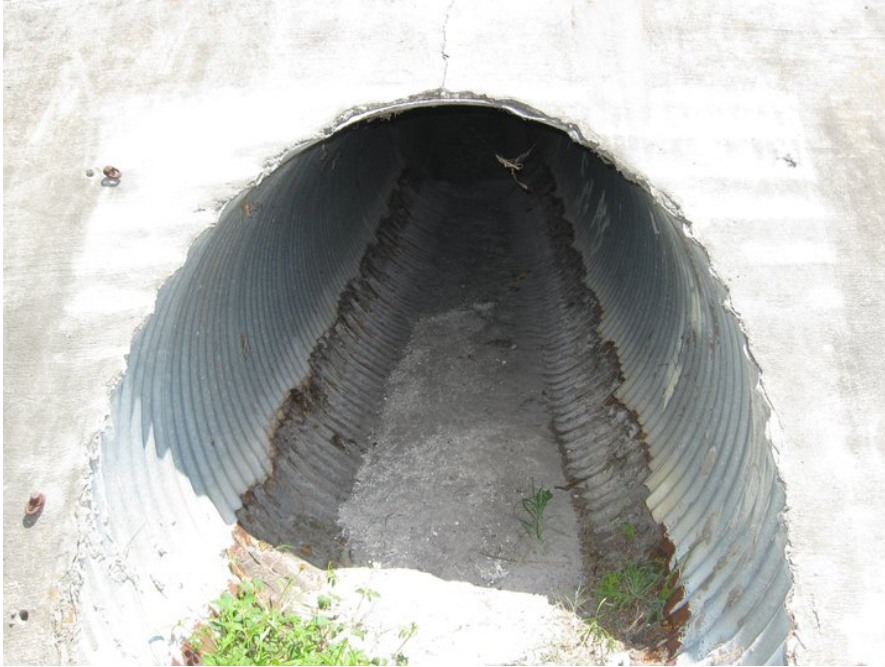
Figure 4. Invert deterioration in corrugated metal culvert.

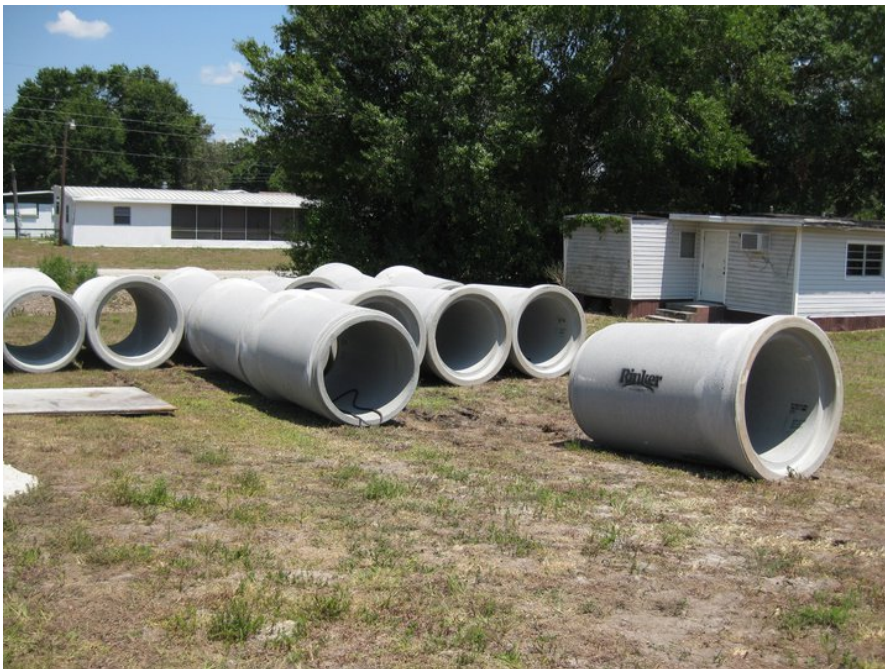
Figure 5. 48-inch diameter reinforced concrete pipe will replace a failing corrugated metal culvert.

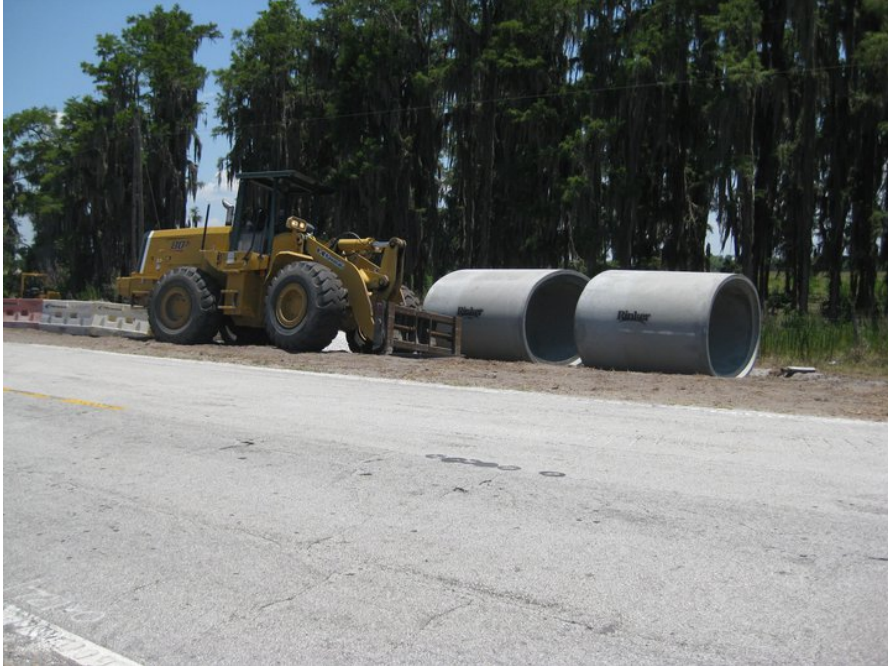
Figure 6. 63x98 HERCP to replace failing corrugated metal culverts along Canoe Creek Road.
